Stop Corrosion  
Extend Life

With Advanced Anode  
Technology

## Hybrid corrosion protection of chloride-contaminated concrete

## 1. Patch repair protection (Reactive)

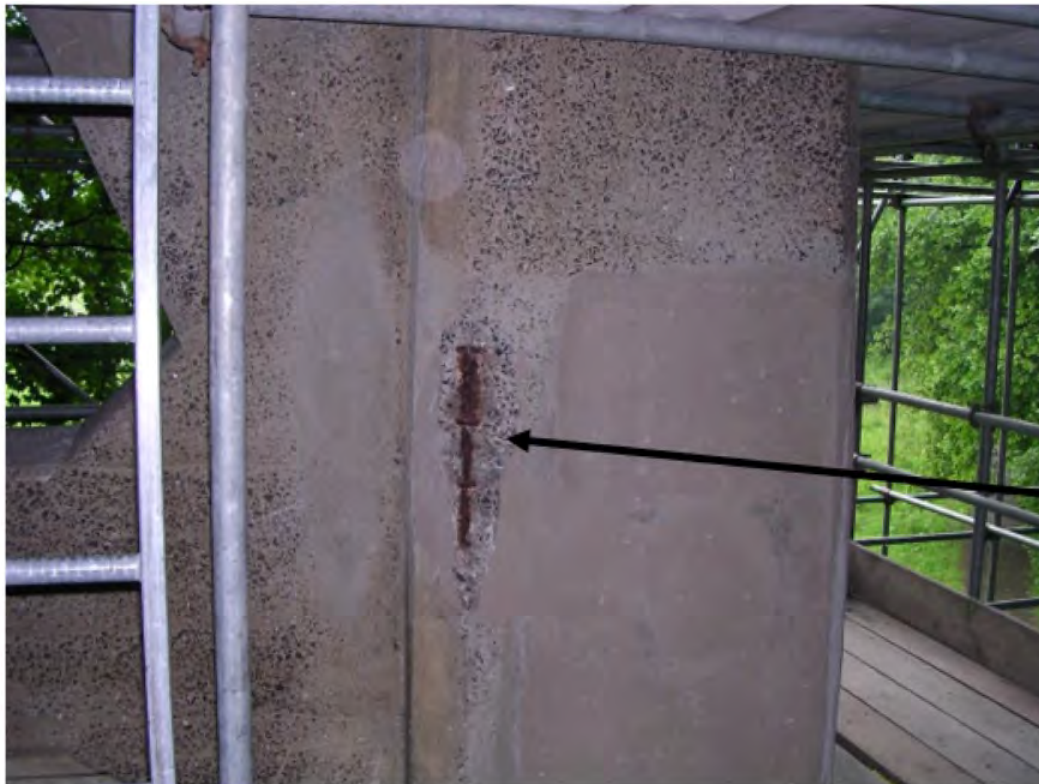
The problem ... “the newly established cathodic area within the repair will drive the new anode site in the contaminated region”

‘Incipient’ corrosion

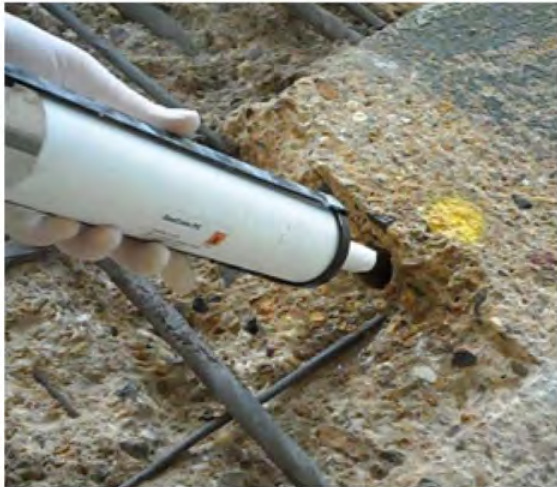
## PatchGuard Installation on a car park in Letchworth, UK

1. Drill a hole and apply PG Mortar

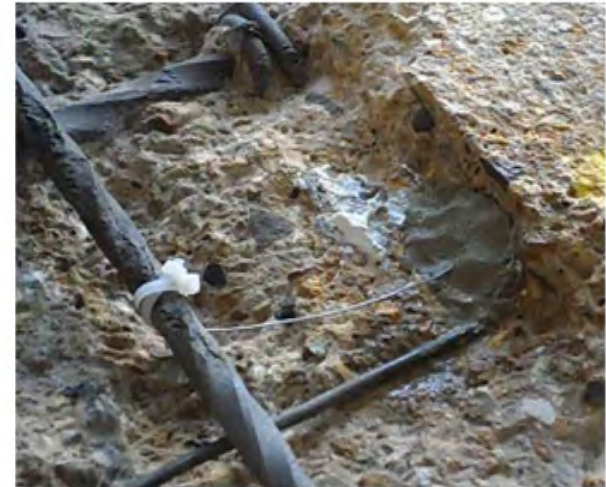
2. Insert the anode

3. Fix anode wire to steel and apply repair mortar

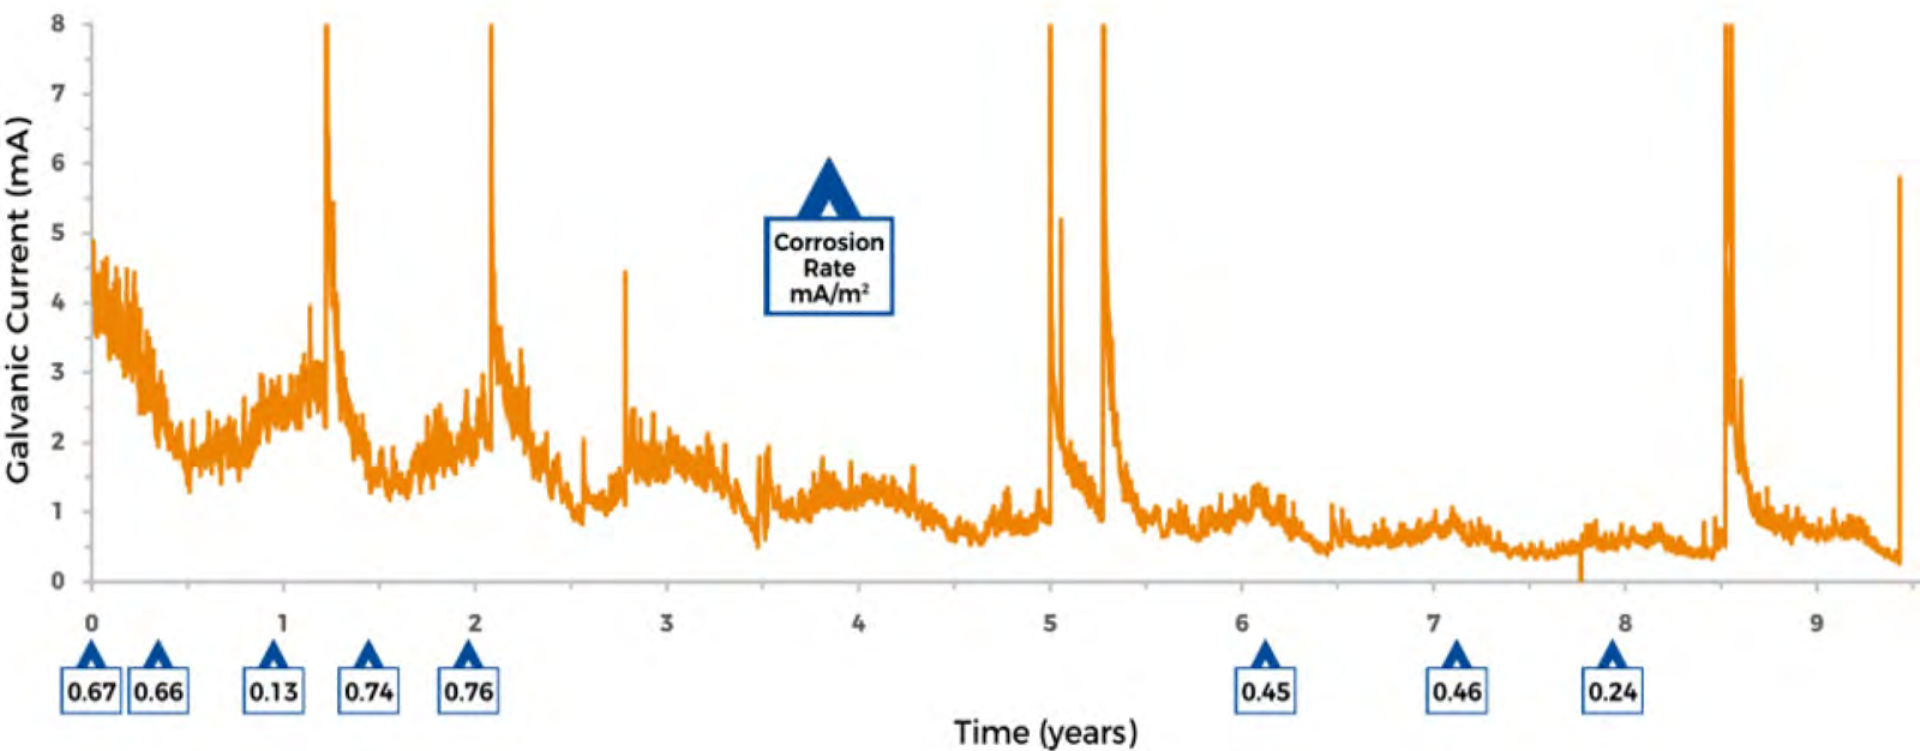
## Whiteadder Bridge - Northumberland

# DuoGuard – performance data

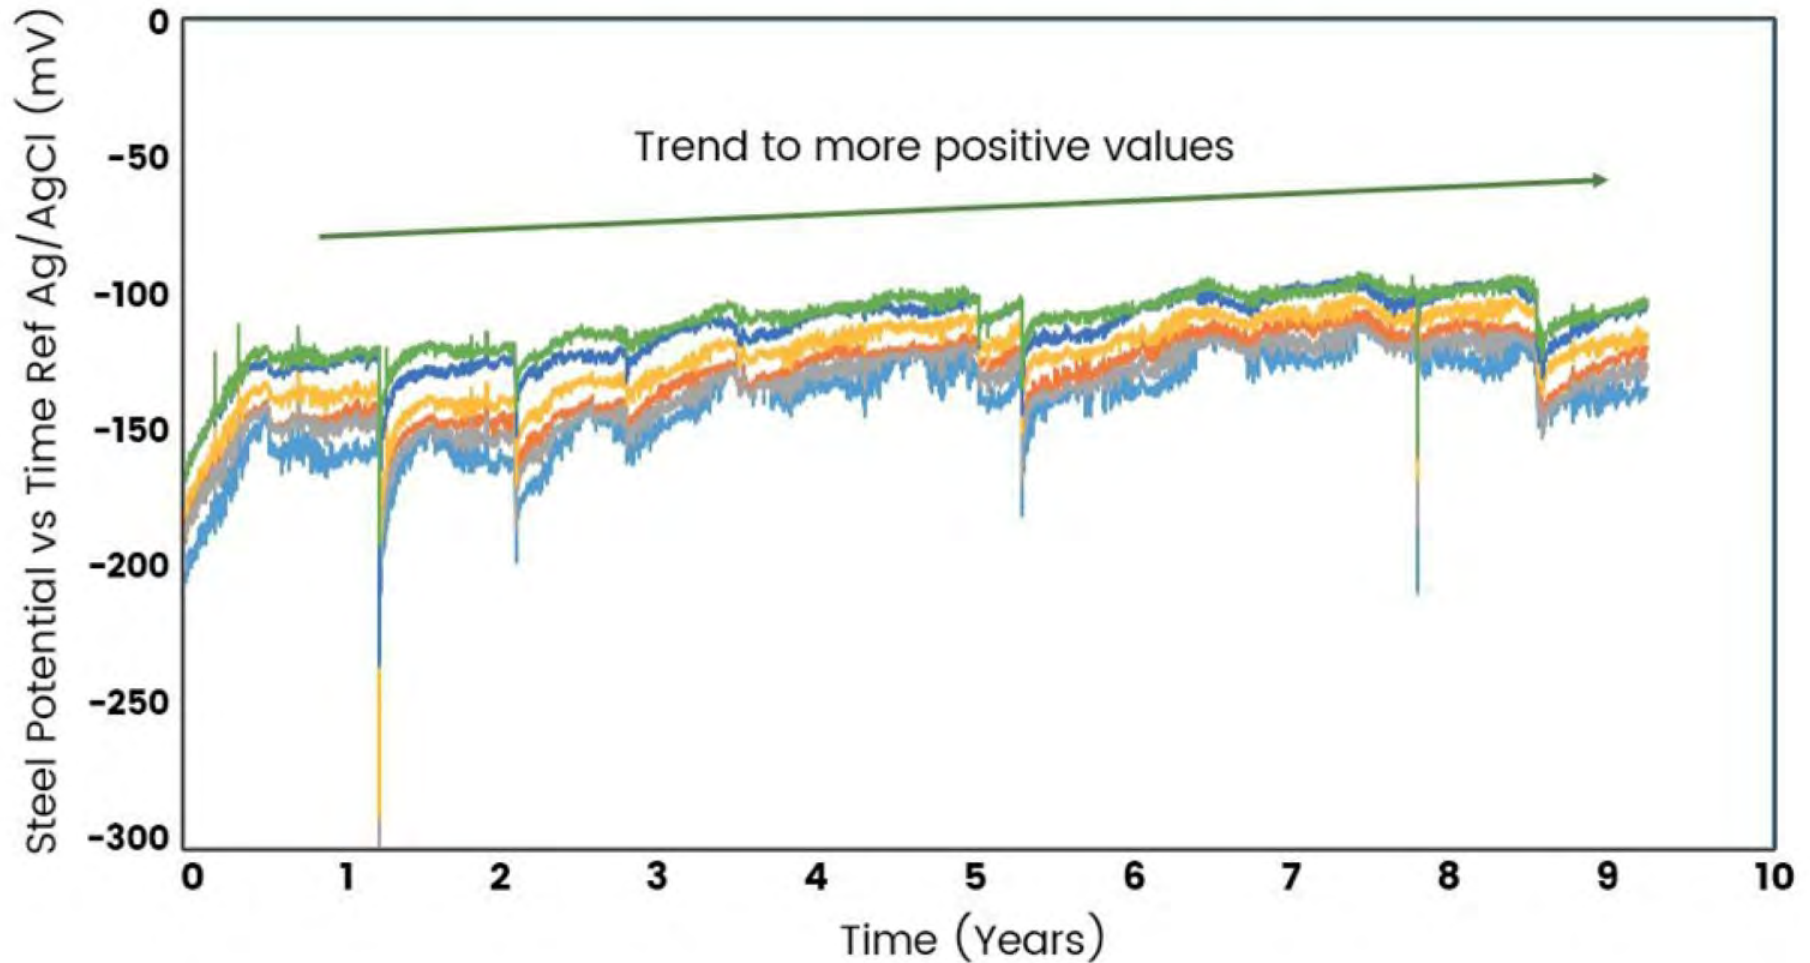
## Whiteadder Bridge - Northumberland

# DuoGuard – performance data

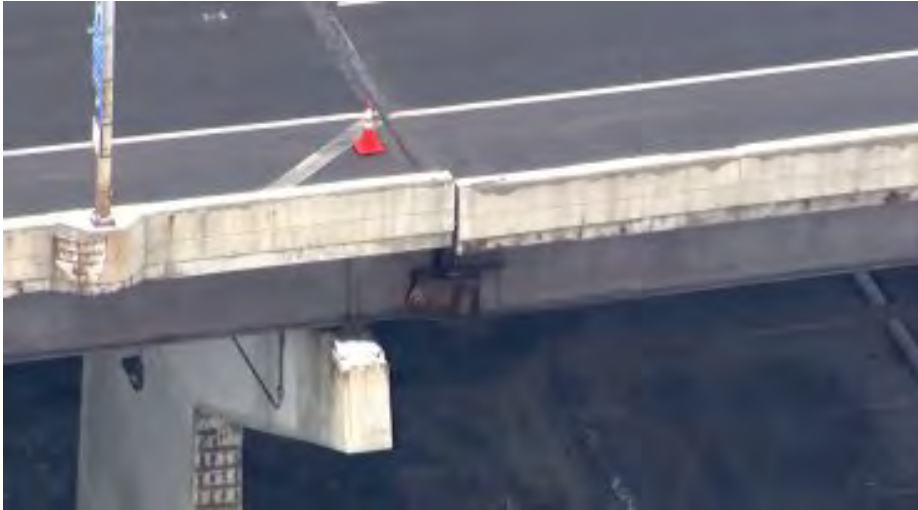
Half Joint Failure,  
Lake Shore Drive,  
Chicago

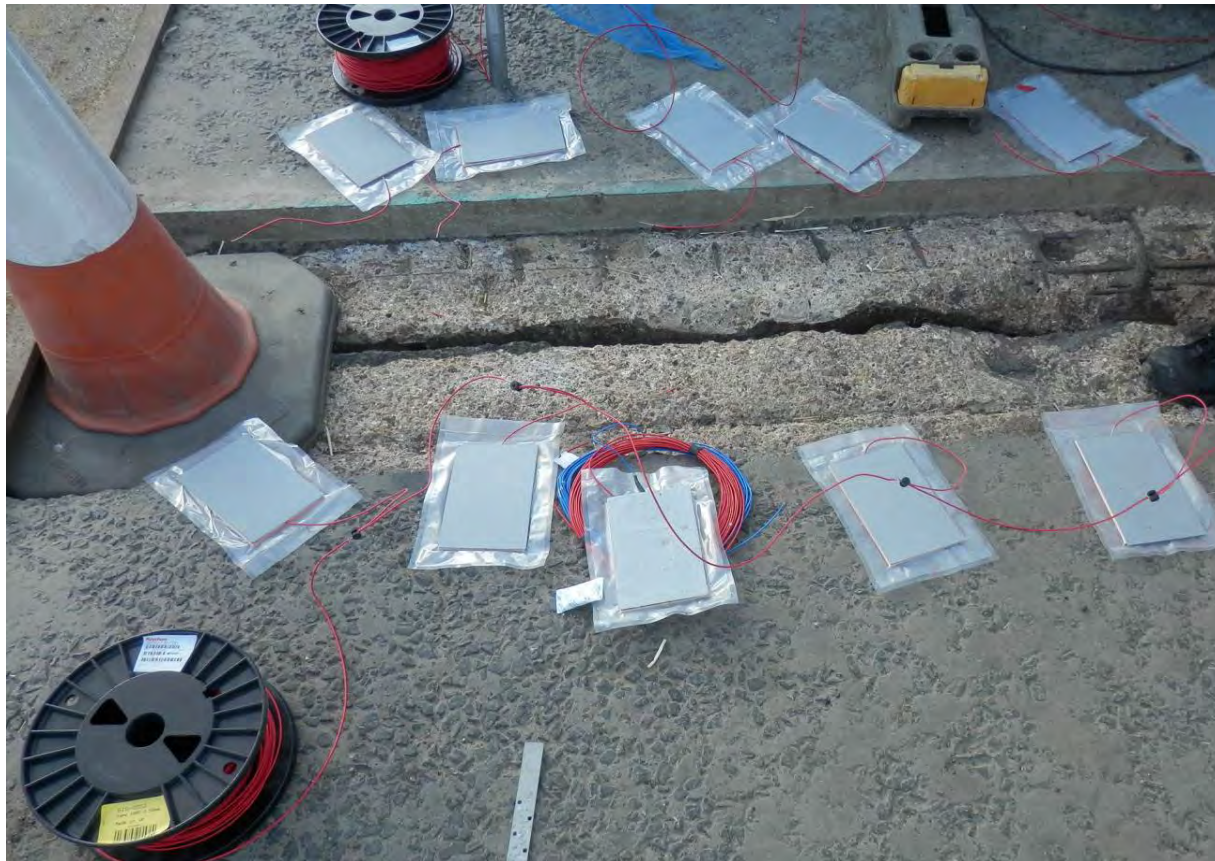
ProtectorJoint anodes connected ready for installation
