## TECHNICAL MORTARS AND STRUCTURAL STRENGTHENING

July 2022

# AGENDA

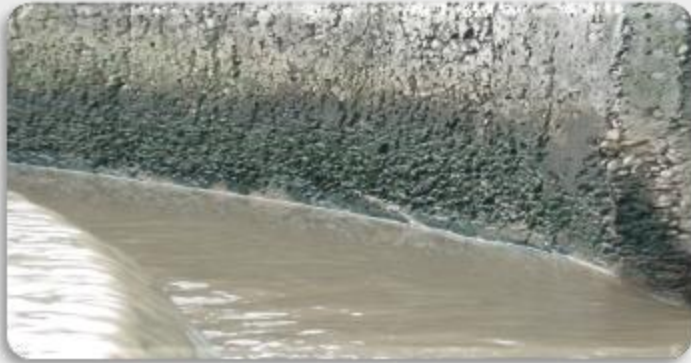
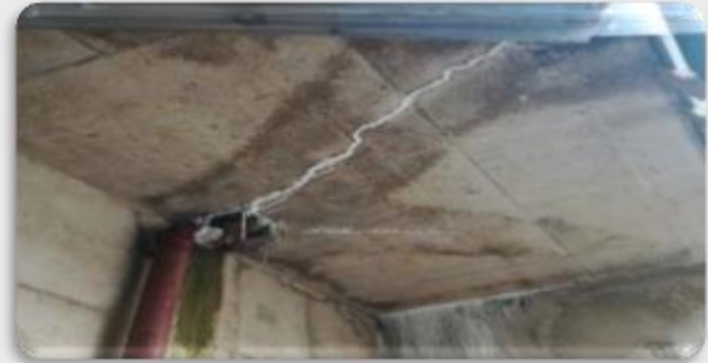
# SULPHATE ATTACK

- Physical

- Chemical

$\text{Na}_2\text{SO}_4 + \text{C}_3\text{A}$ , CSH, monosulfate aluminate  $\rightarrow$  Ettringite

$\text{K}_2\text{SO}_4 + \text{C}_3\text{A}$ , CSH, monosulfate aluminate  $\rightarrow$  Ettringite

$\text{CaSO}_4 + \text{C}_3\text{A} \rightarrow$  Ettringite

$\text{MgSO}_4 + \text{CSH} \rightarrow \text{Mg}(\text{OH})_2$  Brucite  $\rightarrow$  Dissolves forms more Mg and the process is repeated

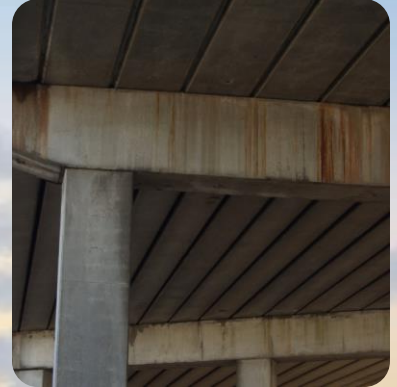
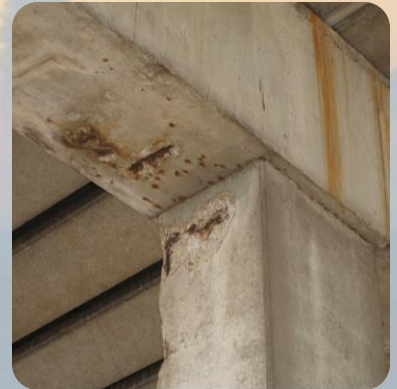
# CARBONATION INDUCED CORROSION

- Caused by the ingress of atmospheric gases
- $\text{Ca}(\text{OH})_2 + \text{CO}_2 = \text{CaCO}_3 + \text{H}_2\text{O}$
- pH reduces from 13.0 to  $< 9.0$
- Neutralizes protective alkalinity in concrete

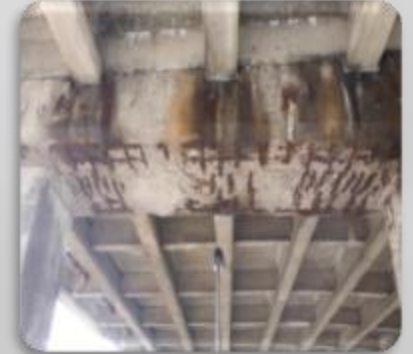
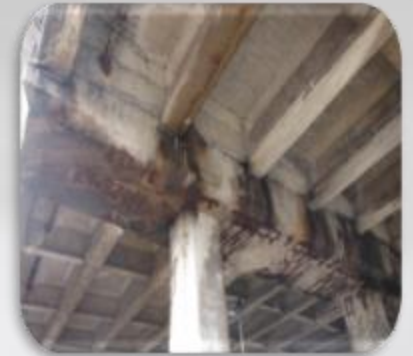
# CHLORIDES INDUCED CORROSION

- Marine Environment (salt water)
- De-icing Salts
- Cast in chlorides
- Accelerators (Pre-1980's)

- Attacks passive layer by changes in electro-potential

Without removal of all chlorides corrosion will continue at new sites!

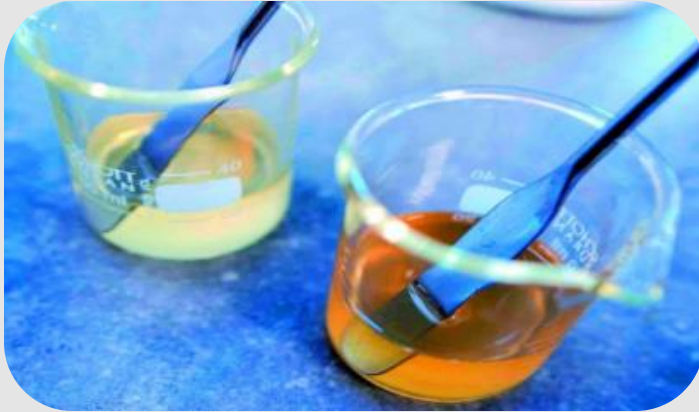
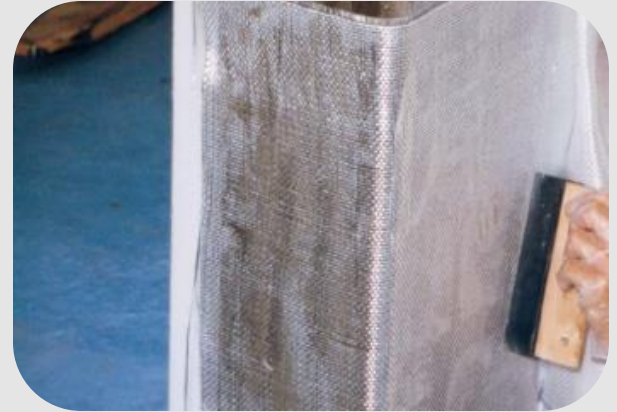
# INTRODUCTION TO RESIN AND FIBRE TYPES

- What are fibre reinforced polymers?
  - **Fiber-reinforced polymer (FRP)** is a composite material made of a **polymer matrix** reinforced with **fibers**.

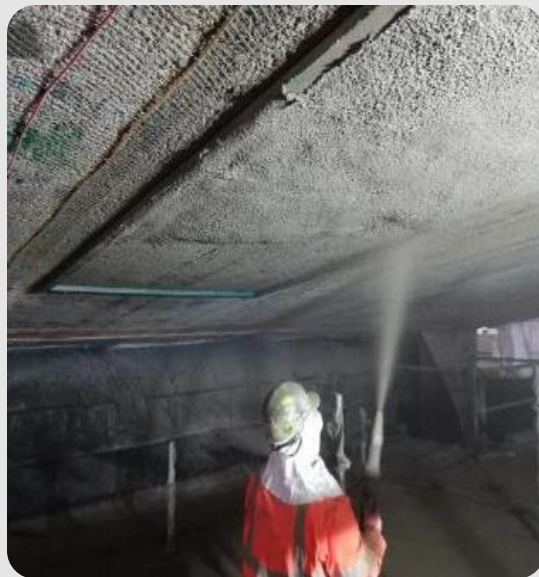
New Elvet Bridge, Durham

# SPRAYED CONCRETE REPAIRS

- Large areas of structural concrete
- Highway structures
- Fire damaged concrete structures
- Rock and embankment stabilization

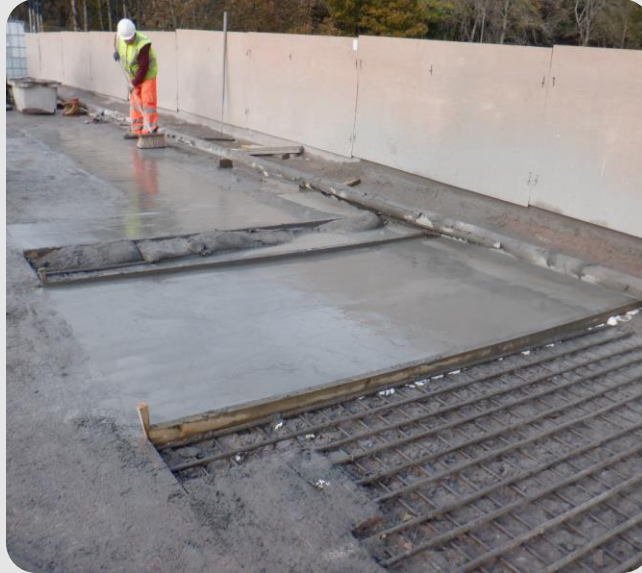
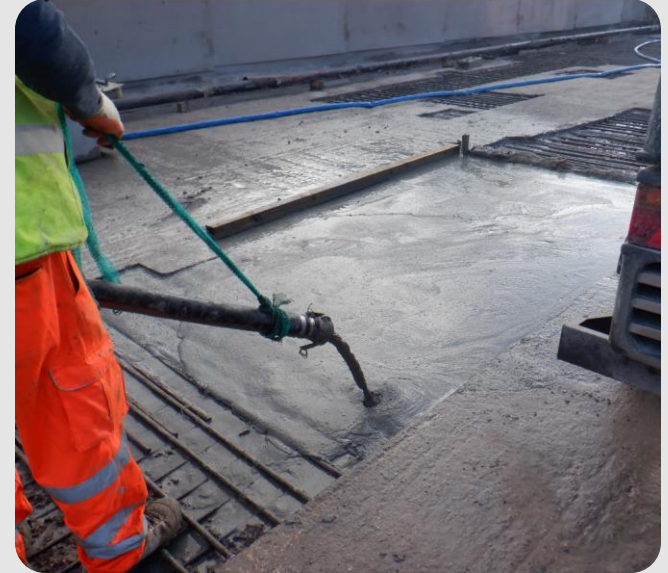
# A90, GLENCARSE, PERTH

- Where a flowing, self-compacting repair concrete is required
- Where a structural (R4) repair concrete is required
- In areas of congested steel or difficult-to-access reinforcement

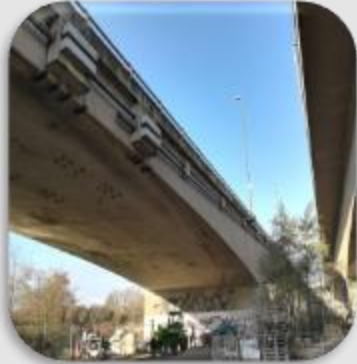
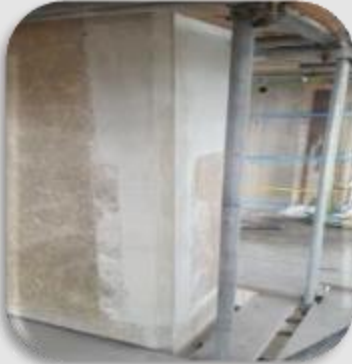
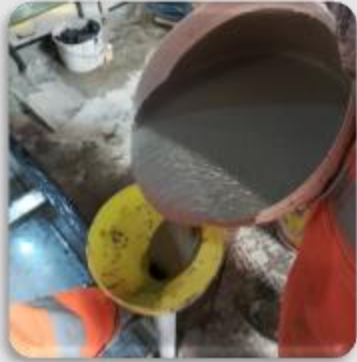
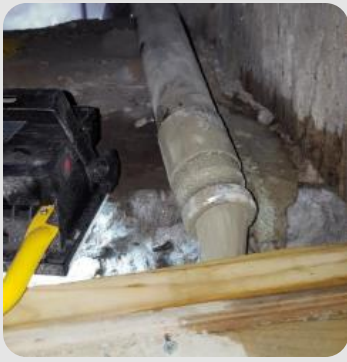
# RECASTING CONCRETE

- Flowable & pumpable cementitious non shrink structural repair concrete ideal for deep section repairs and grouting
- webercem five star repair concrete CP (R4)
- R4 Hand Placed Mortars

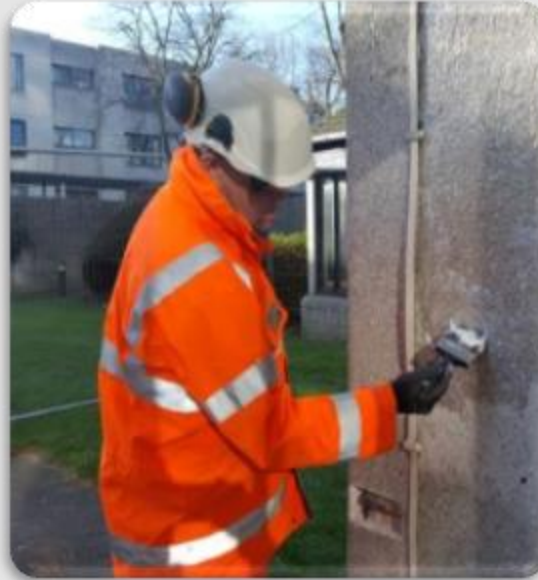
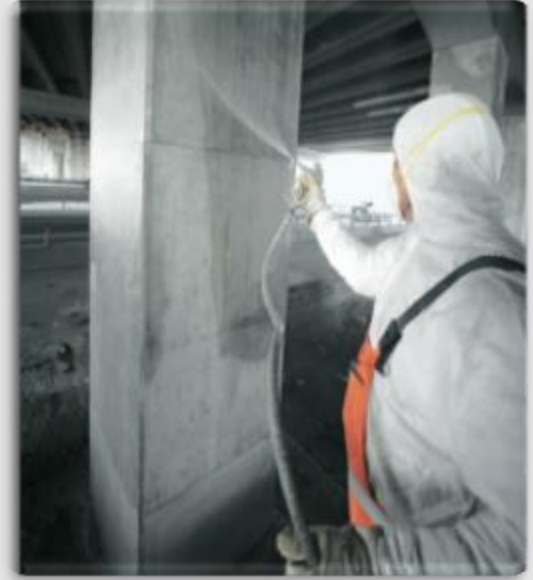
# CONCRETE PROTECTION

## webertec aquapel crème

- Highly water repellent, but breathable
- Prevents chloride ingress, prevents carbonation
- Long-life (>25 years and counting)
- Not affected by mechanical impact & retains concrete appearance

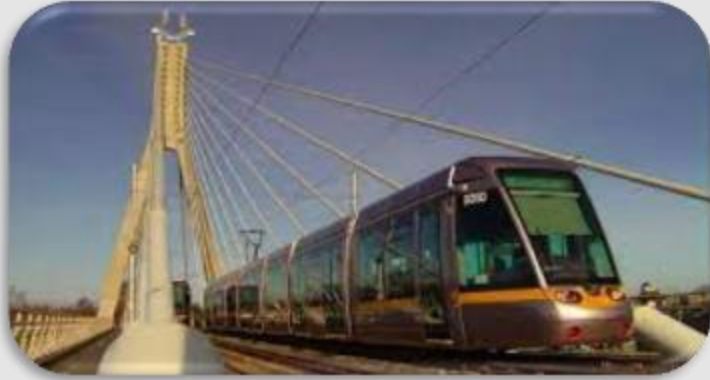
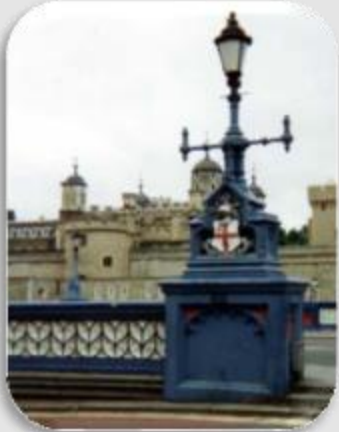
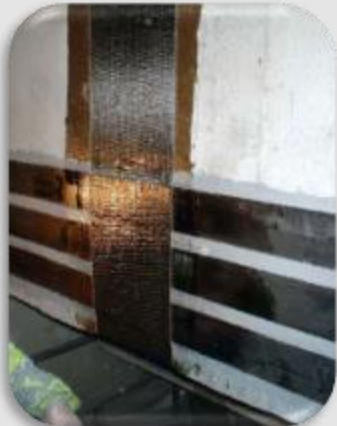
# FRP STRENGTHENING & EPOXY RESINS.

- Structural strengthening of cast iron lamp stands for Tower Bridge, London
- Corkerhill Road Bridge, Paisley, Scotland
- A647 Henconner Lane Bridge, Stanningly Bypass, Leeds
- M6 Cumbria Bridges, J38—J40
- M2 Gillingham Bridge, Junction 4
- M62 Ashfield Bridge, Milnrow - J21
- Taney Bridge, Dundrum, Dublin
- Dockland Light Railway - London City Airport link
- Deansbrook Viaduct - M1 Motorway
- Pont Glanhros Wales Culvert

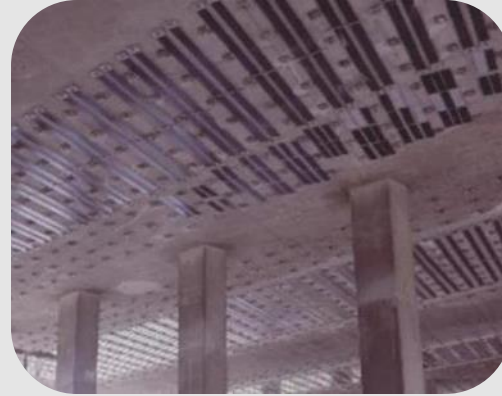
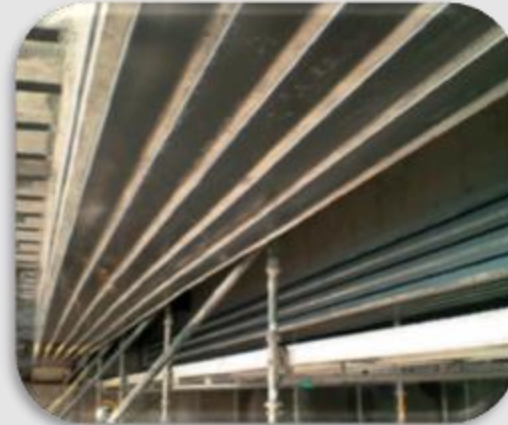
# BARNES BRIDGE, M60 MOTORWAY, CHEADLE IN CHESHIRE

- Client: Highways England
- Carbon Fibre strengthening
- Time saved (50% on programme) using FRP
- 5,500 metres of carbon fibre plate used
